**WearComp®**

## INDUSTRIAL APPLICATION: EXTRUSION & FORGING EQUIPMENT

# WearComp® Material: Wear and Mechanical Test Data

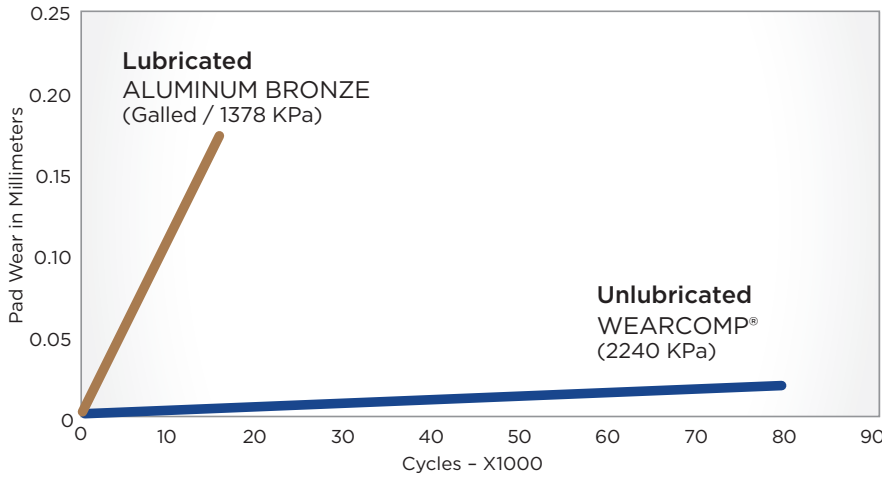
## RECIPROCATING WEAR TESTING

Reciprocating wear tester (50mm stroke, load 1378-2240 KPa)

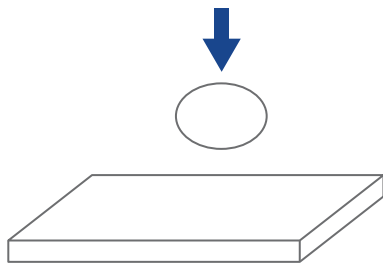
## Impact Data

Falling ball impact test (1.36 Kgs ball dropped from 2.28 Mtrs)

Material	Impact Energy (Mtrs Kgs)	Rebound (Mtrs)
ALUMINUM BRONZE	3.10	0.45
WEARCOMP®	3.10	1.37
